# NATIONAL ADVISORY COMMITTEE FOR AERONAUTICS

No. 1095

MARINE EXPOSURE TESTS ON STAINLESS STEEL SHEET

National Bureau of Standards

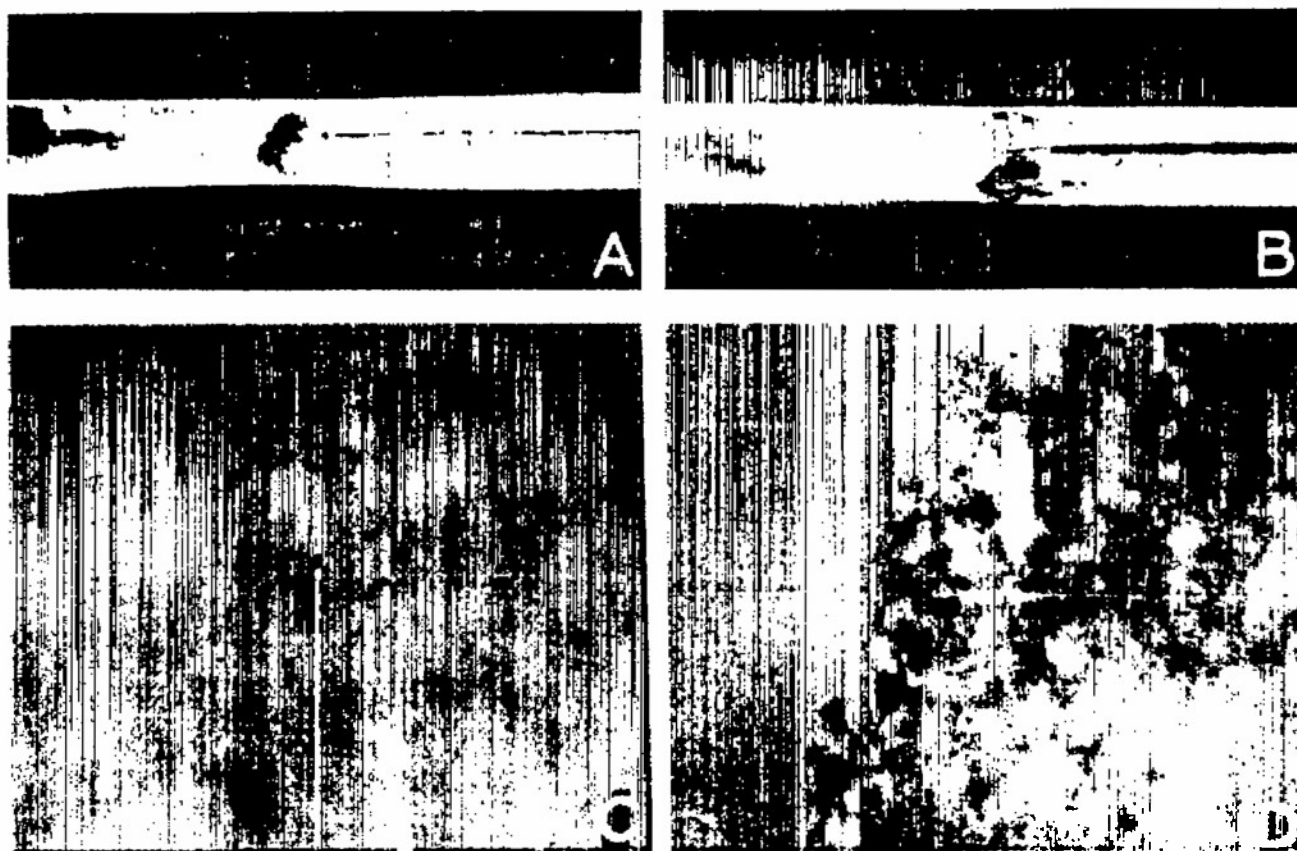
After 15 days of exposure in the boiling chloride solution exposed cross sections cut through some of the welds on steels C-1 and D-5 (figs. 23a and 23b) revealed severe corrosion. At the end of 120 days two of the welds in the titanium-bearing steel C-1, had failed (figs. 23c and 23d); while welds in the other samples contained only superficial pits.

Figure 23.- Corrosion on shot-welds exposed to a boiling solution of mixed chlorides in laboratory tests. A, Pits in Steel C-1 (titanium-bearing) on a welded cross-section exposed for 15 days. x 10; B, Steel D-5 (columbium-bearing), exposed under the same conditions as in "A". x 10; C, Pin-hole on Steel C-1 shot-weld, which developed in 100 days. x 9; D, Corrosion at the edge of a shot-weld on Steel C-1 after 120 days. x 9.

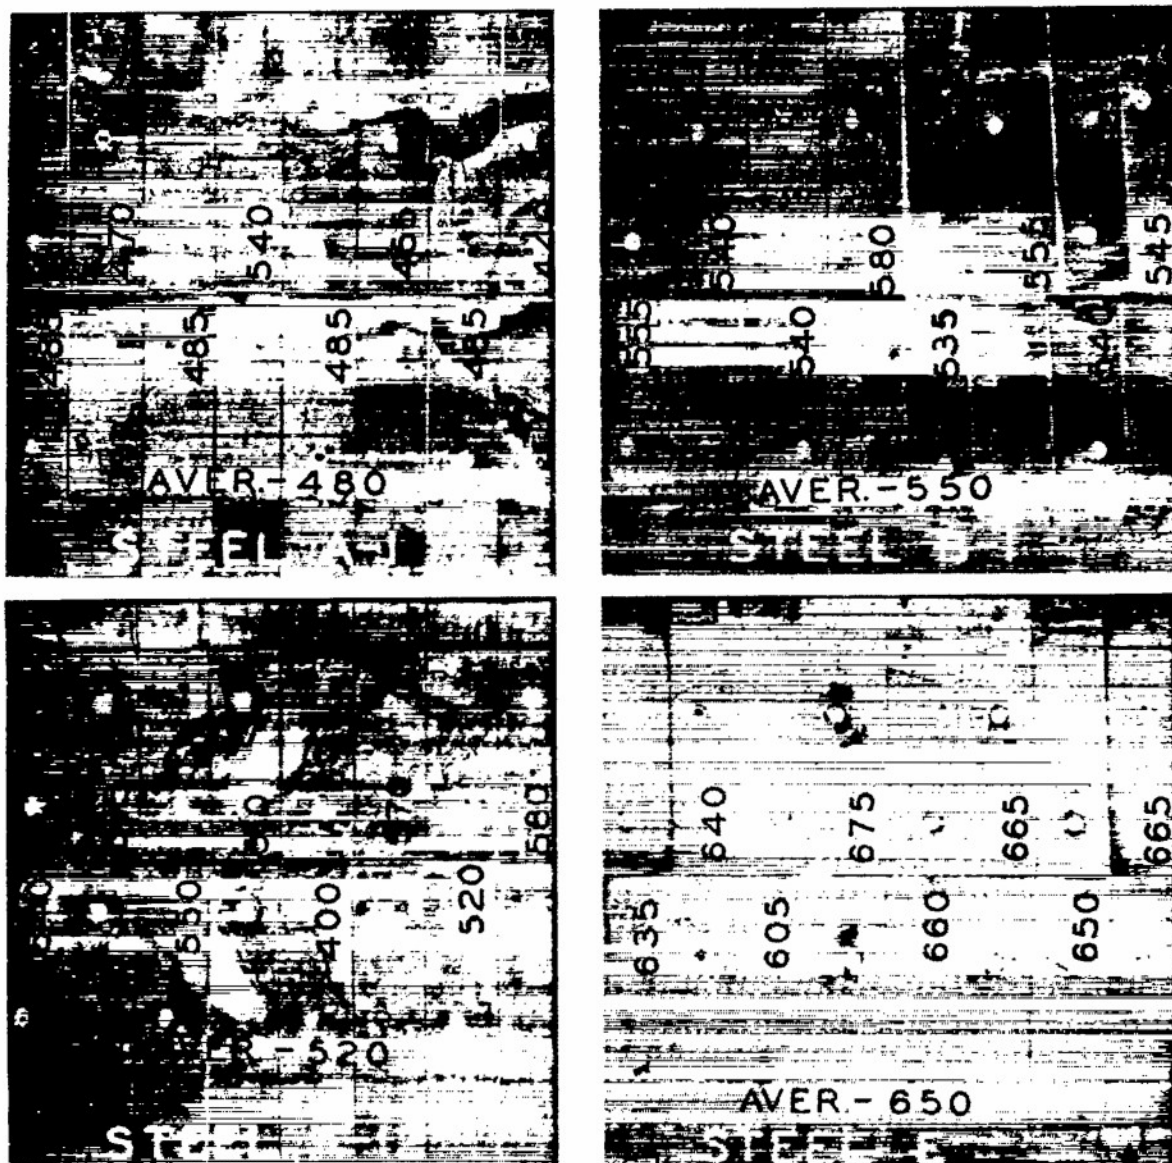
Figure 26.- The faying surfaces of panels, comparable to those shown in figure 25, but exposed to the weather for three years at Hampton Roads, Va. Surfaces to which no grease was applied prior to welding (Steel A-12) exhibit considerable rust. x 3/4.

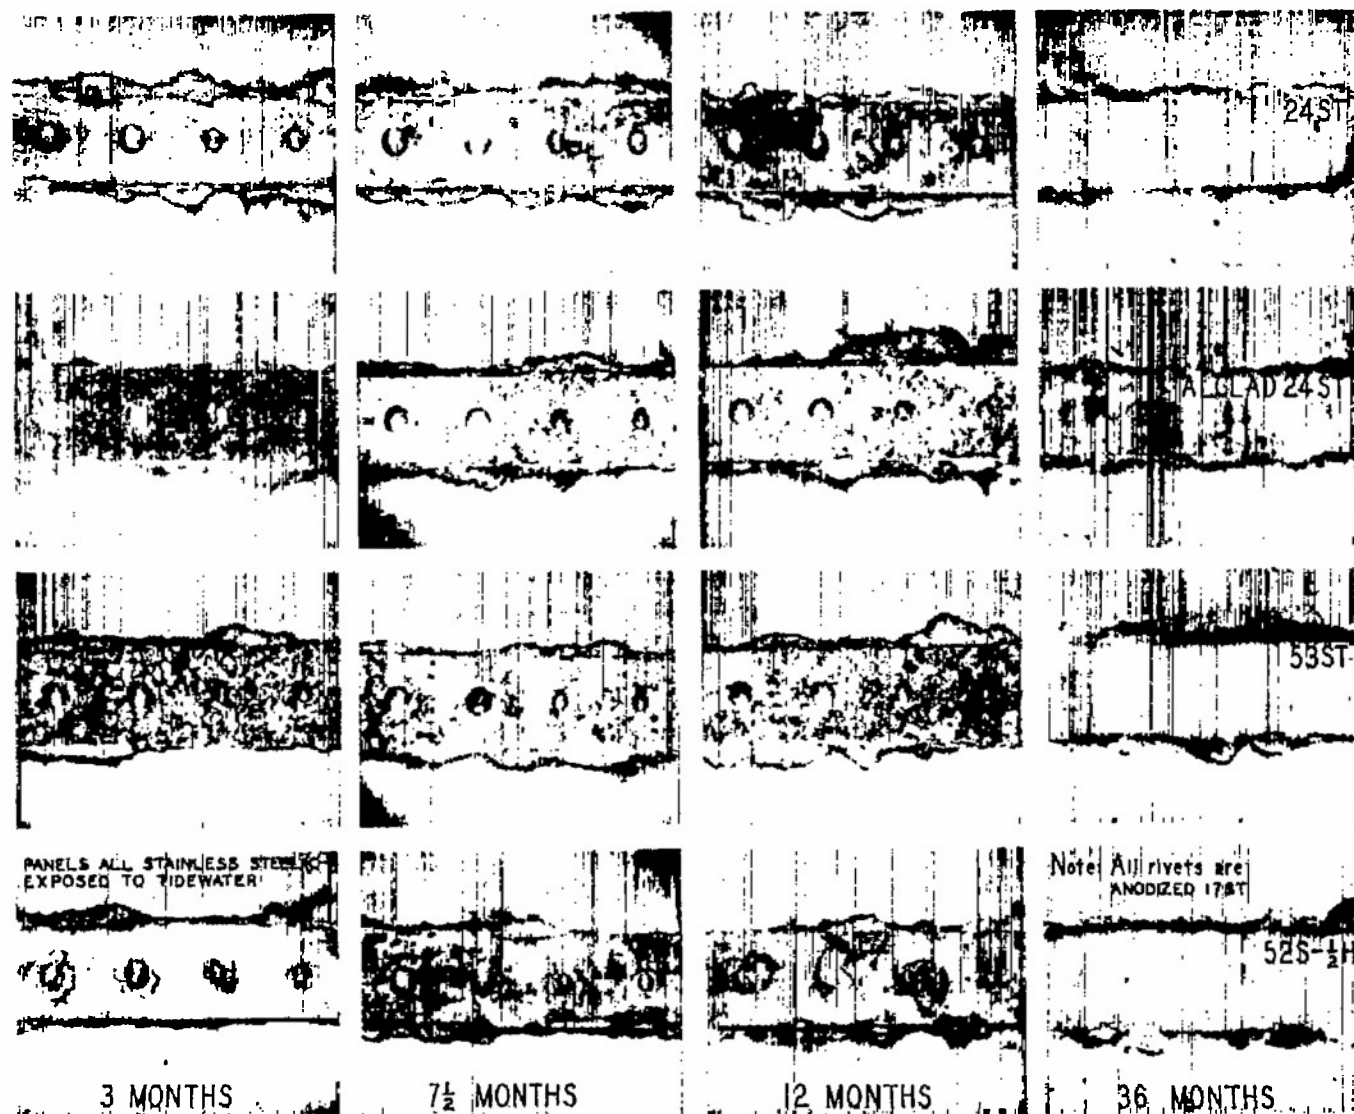
Both the macroscopic and microscopic examinations revealed that alloys 24S-T and Alclad 24S-T were the most severely attacked, with 53S-T somewhat less so, and 52S-1/2H the least. This does not necessarily indicate the order of the potential differences involved since the 52S-1/2H and Alclad 24S-T alloys are inherently the most resistant to corrosion.

Figure 28.- Strips of aluminum alloys, coupled in a 1:7 area ratio on panels of stainless steel, and exposed to the tidewater at Hampton Roads, Va. for the periods indicated. Note the severe corrosion on the strips and the quantities of corrosion products accumulated at the edges of juncture. x 1/2.

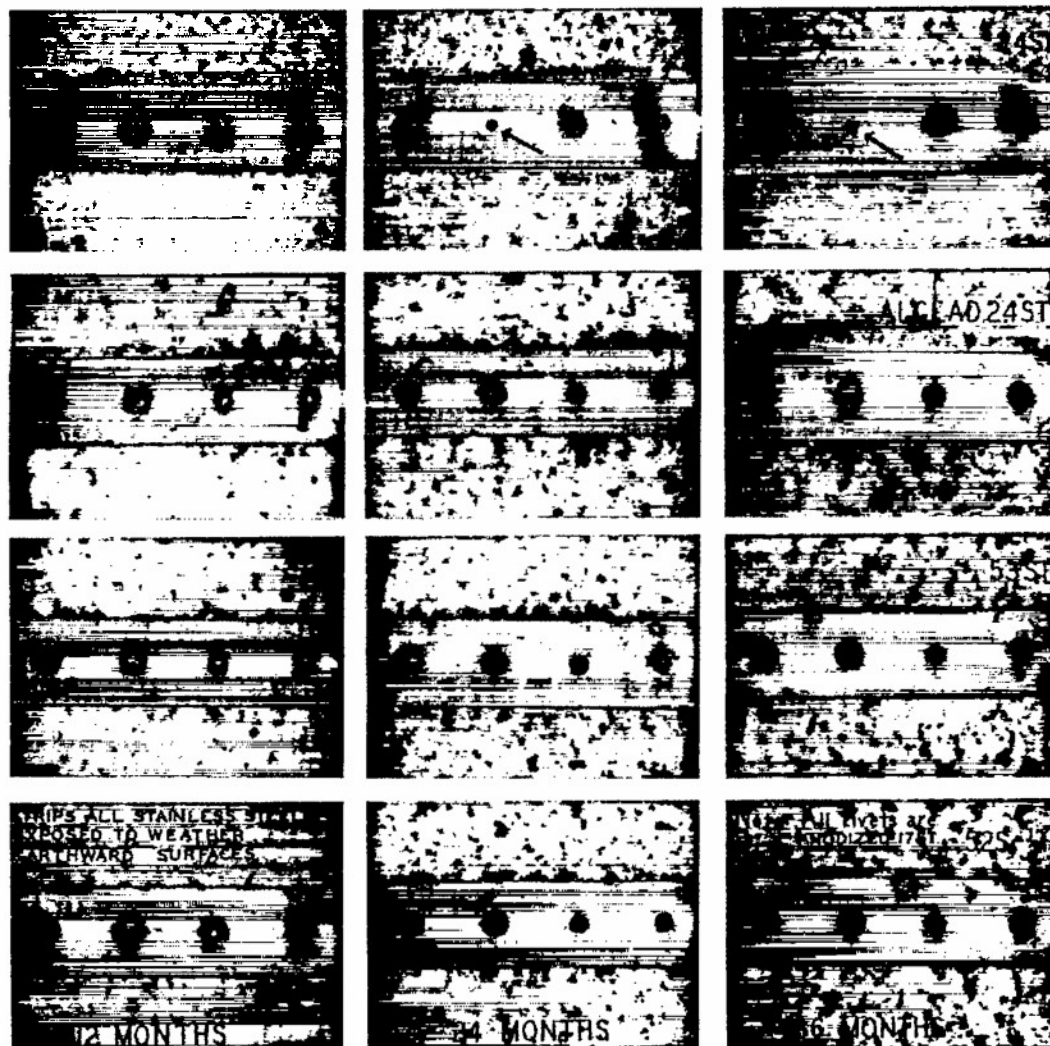
Identical couples exposed to the weather (fig. 30) corroded similarly to those in tidewater but at a much slower rate. In some instances (fig. 30, alloy 24S-T) the accumulation of corrosion products at the faying surface resulted in sufficient stress to break off rivet heads. Stress-corrosion cracks, for the same reason, were present on some of the 24S T exposed to the weather or tidewater, and on the Alclad, 24S-T strips exposed to tidewater (fig. 31C) attached to stainless steel panels.

Figure 30.- Earthward surfaces of strips of stainless steel coupled in a 1:7 area ratio with panels of aluminum alloys, and exposed to the weather at Hampton Roads, Va. for the periods indicated. Note that two rivet heads, joining the steel to alloy 24ST (arrows), have broken off because of the stresses imposed by the corrosion products at the faying surfaces. x 1/2.

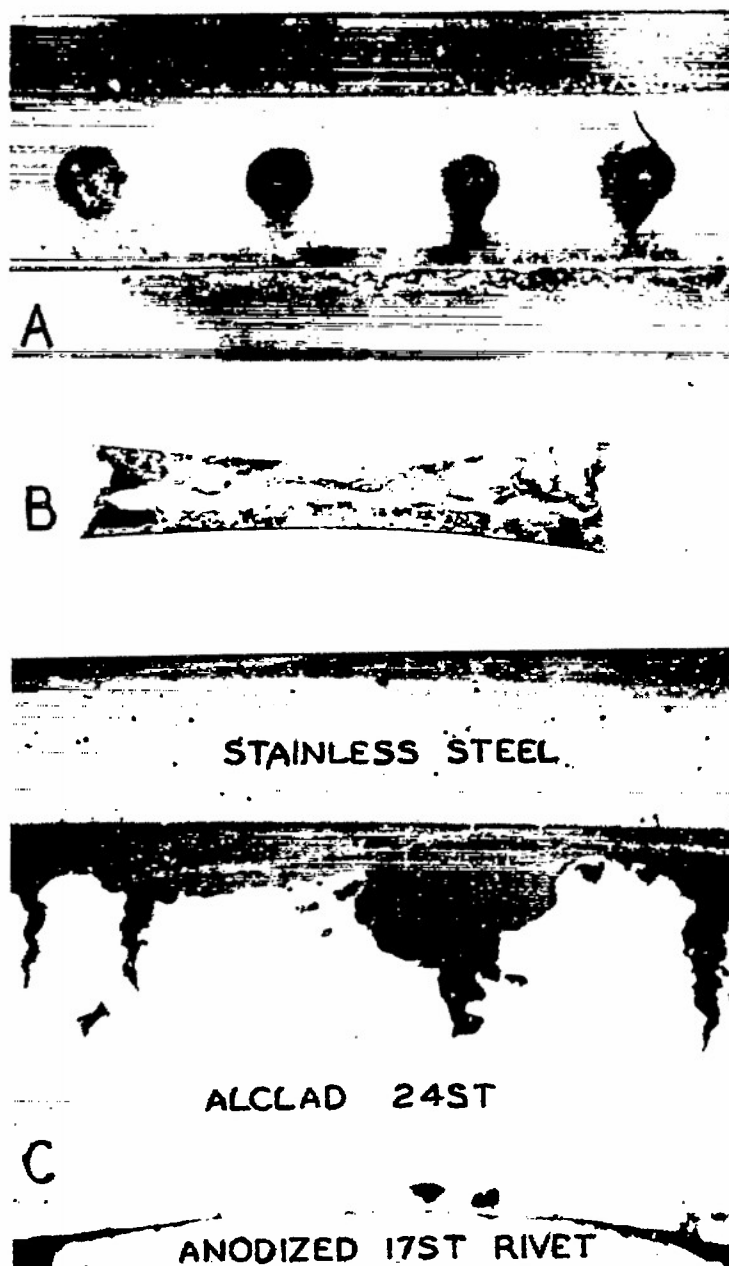
years corrosion products at the faying surfaces (fig. 31A and 31B) were sufficient in quantity to cause stress corrosion cracking of the stainless steel strips. The paint between the faying surfaces on the painted panels afforded excellent protection, and severe corrosion at the couples was not noted until after the second year of weather exposure (fig. 34).

Figure 31.- Examples of stress corrosion on panels having stainless steel coupled with light metal alloys. A, Crack on stainless steel strip joined to a magnesium alloy panel, Dowmetal M. Exposed two years to the weather, earthward surface. x 1. B, Cross-section showing the large amount of corrosion products at the faying surfaces of (A). x 2-1/2. C, Cracks in Alclad 24ST strip attached to a stainless steel panel, exposed to tidewater for two years. x 50.

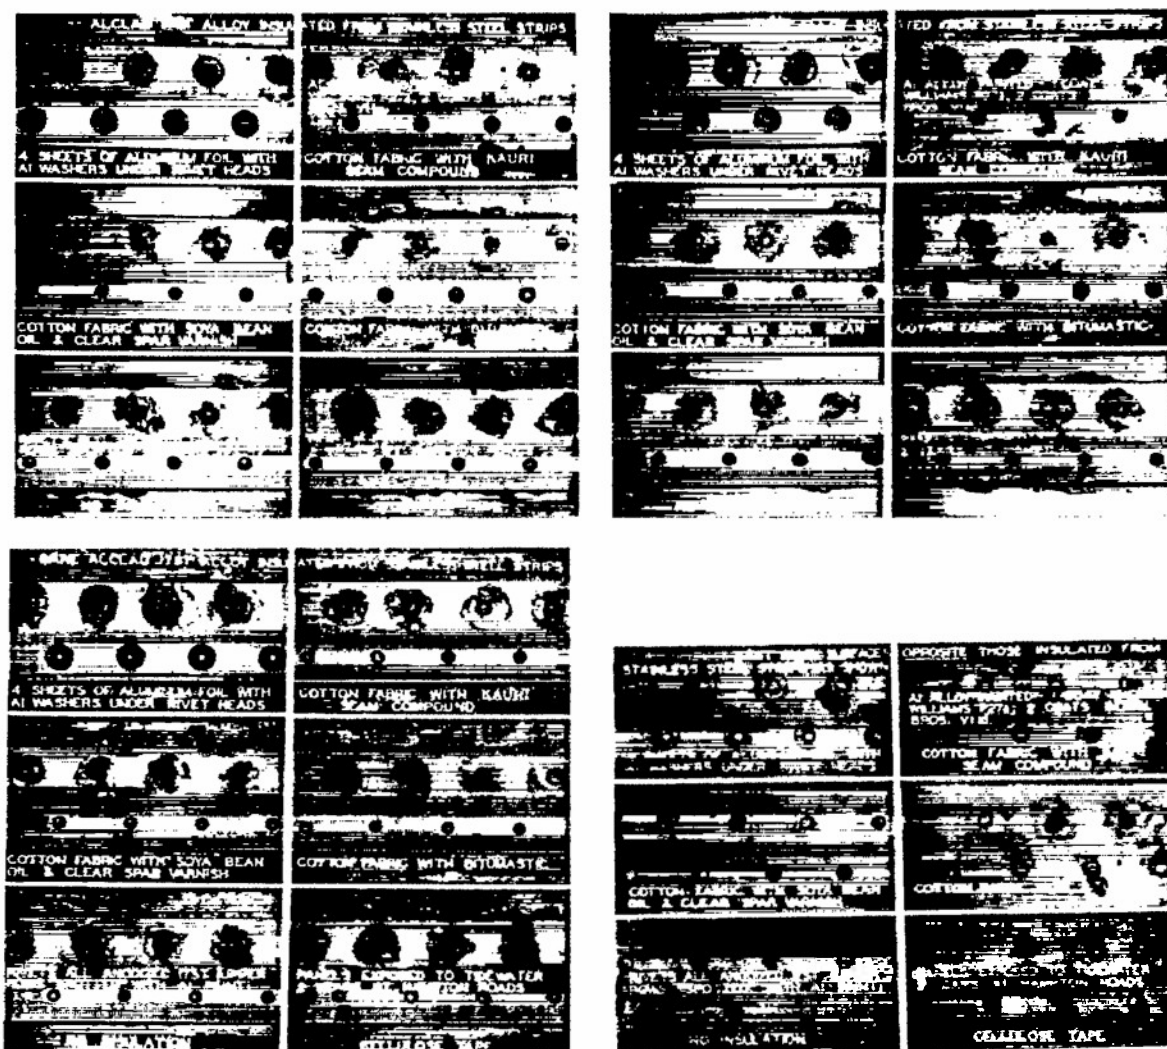
Figure 32.- Panels of aluminum alloys joined to stainless steel strips and exposed to tidewater at Hampton Roads, Va. for two years with the various insulators between the strips and the panels. The upper rows of rivet heads were painted with an aluminum pigmented varnish. Note the absence of corrosion products along the edges of the strips insulated by aluminum foil. x 2/5.

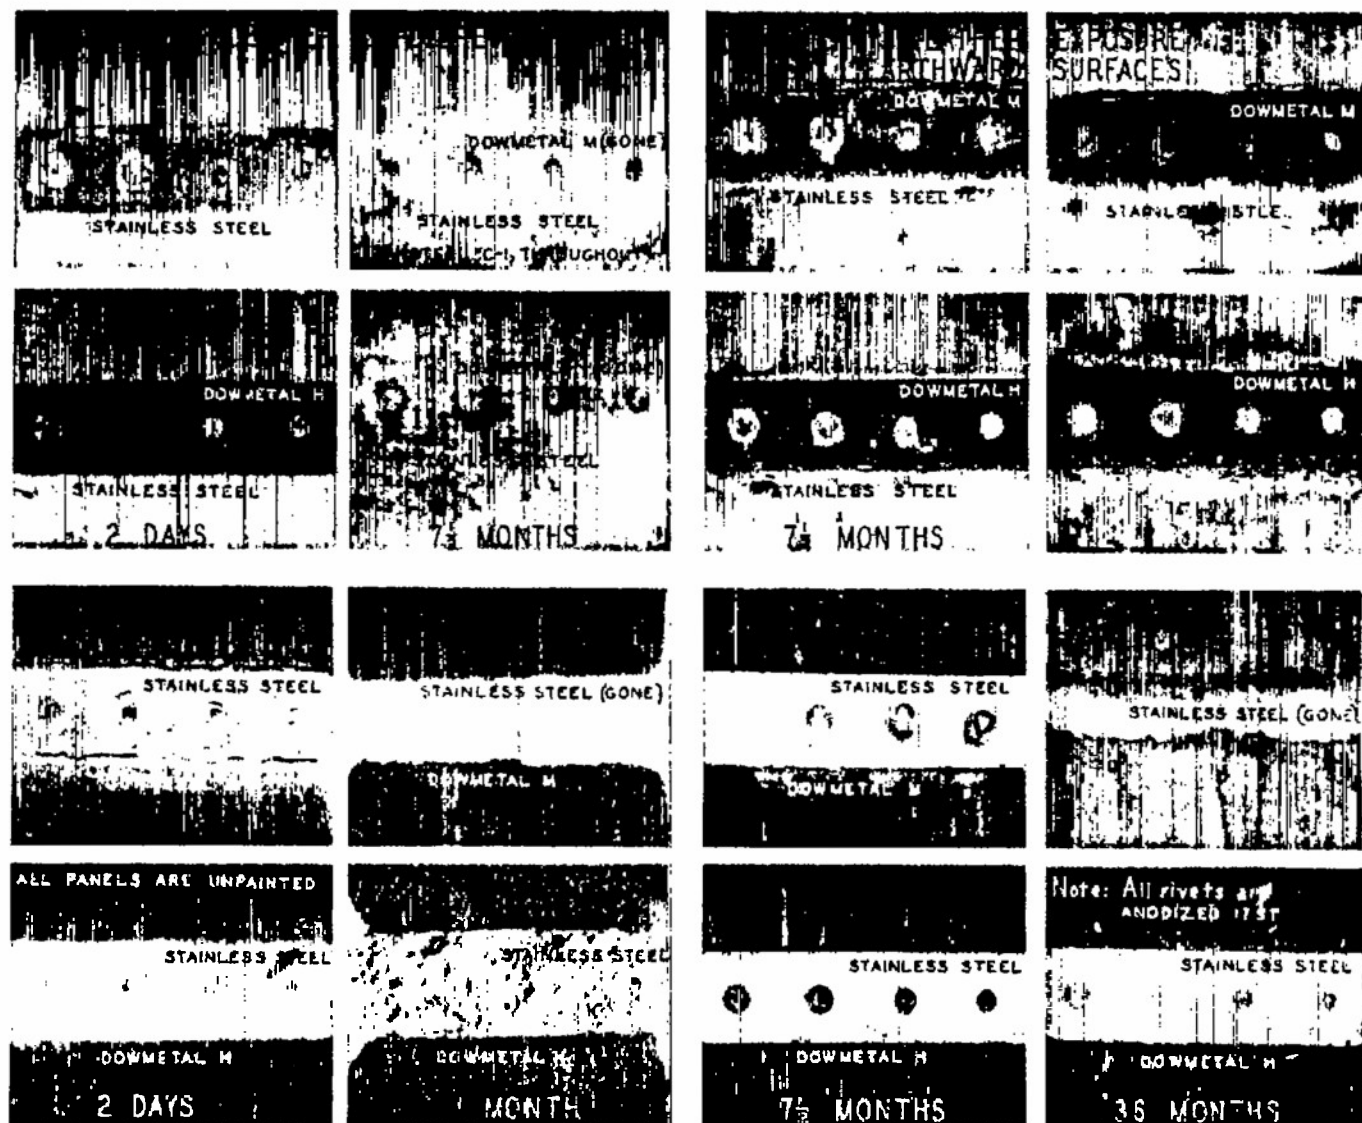
Two unpainted magnesium alloys, Dowmetals M and H, were very severely attacked when coupled with stainless steel, especially when exposed to tidewater at Hampton Roads. Immediately after the first tidewater had covered these panels, violent bubbling of the water occurred, and the reaction was audible at a distance of approximately 15 feet. An adherent white corrosion product was deposited on the steel, which attained a thickness of 0.004 inch on the second day of exposure (fig. 33), at which time the first set of unpainted panels was removed. The white deposit gradually disappeared, and the underlying steel was found unattacked. The Dowmetal M was attacked somewhat more rapidly than the Dowmetal H. The unpainted panels were removed from the tidewater racks after 1/15, 1, 3, and 12 months, while panels painted prior to exposure (fig. 34) were removed from the tidewater racks after 1, 3, 7 $\frac{1}{2}$ , and 12 months. The paint schedule consisted of 1 coat of zinc chromate primer and 3 coats of aluminum-pigmented varnish (Navy Specification V10-d).

Figure 33.- Unpainted panels exposed at Hampton Roads, Va., for the periods indicated, having stainless steel and magnesium alloys in contact with each other. Note the electrolytic deposition of white corrosion products on the uncorroded steel, on panels exposed to the tidewater. The upper quadrants show Dowmetal strips on steel; the lower quadrants show the reverse arrangement. x 1/2.

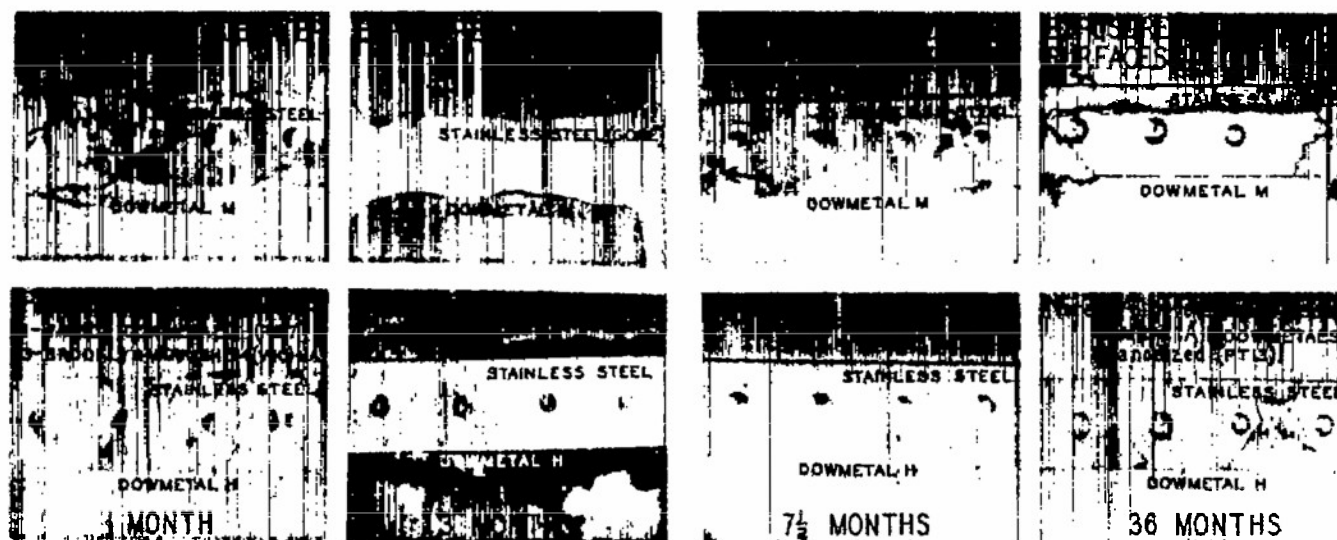
Figure 34.- Painted panels, comparable with those shown in figure 33, after exposure at Hampton Roads, Va. Note that the paint afforded little protection against tidewater exposure, and that it began to fail to adhere to the stainless steel strips after 7-1/2 months of weather-exposure (arrows). x 1/2.

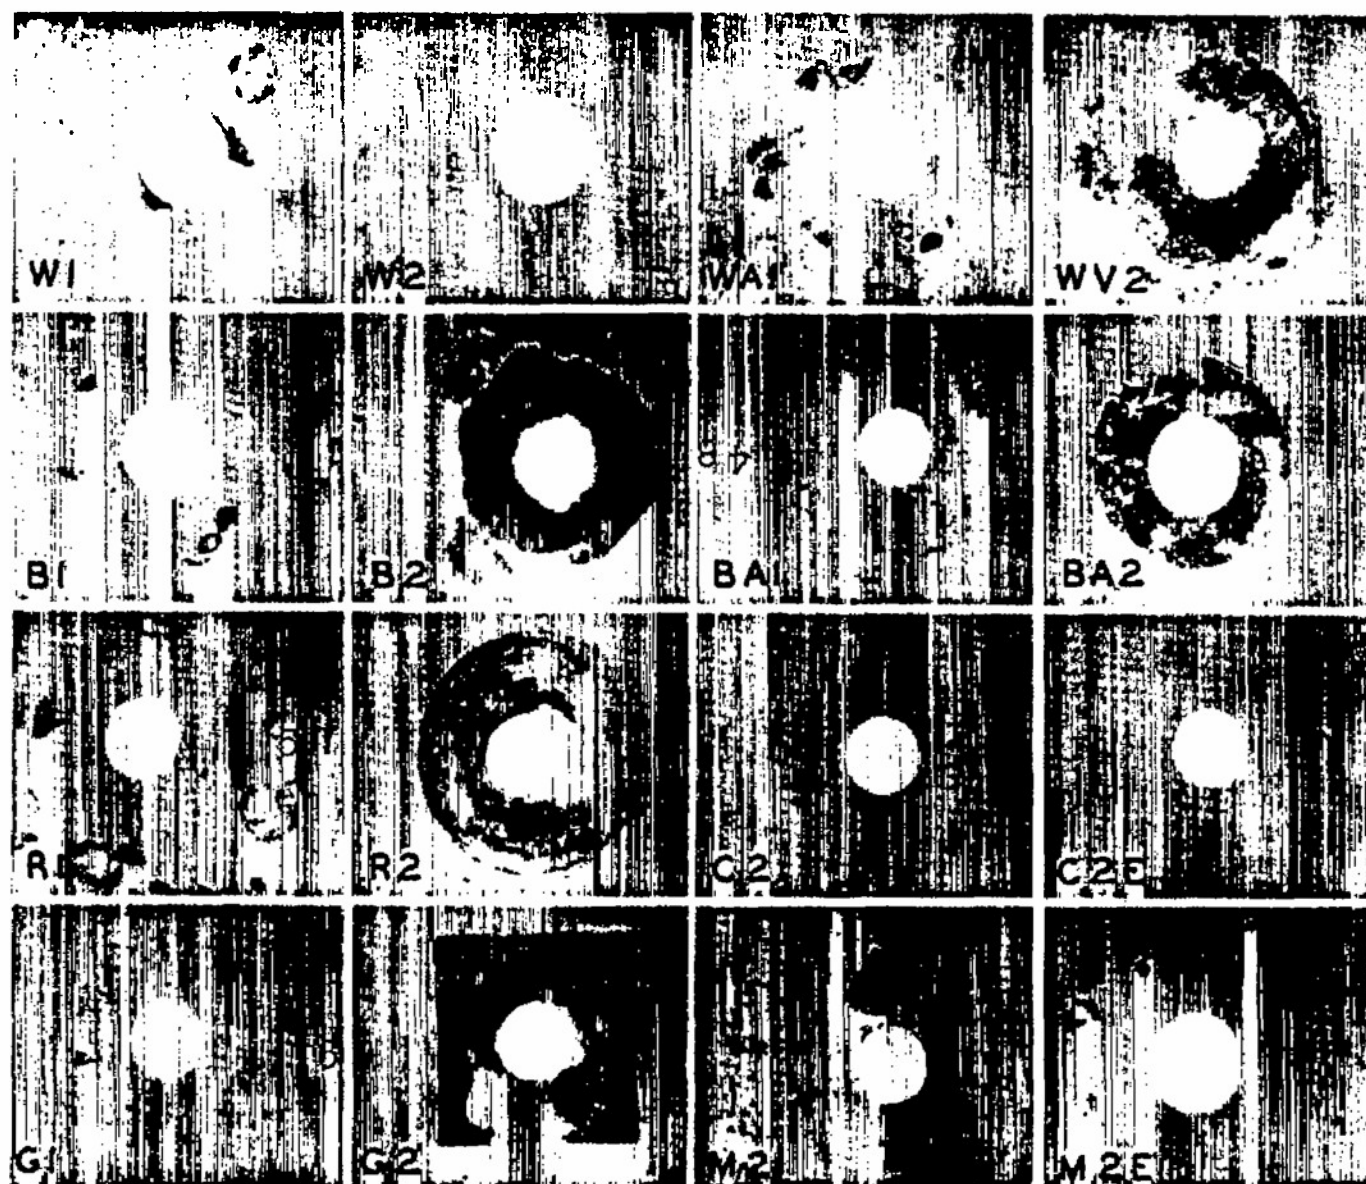
Fig. 36

Figure 36.- The four-point method of supporting panels in the tidewater racks served to prevent corrosion caused by contact with the supporting medium. The symbols:- W, wood, cypress; B, bakelite; R, hard rubber; G, glass; C, copper; M, monel metal; A separator painted with aluminum varnish; V, separator painted with clear varnish; E, mounted to permit an electric circuit; 1, four-point contacts; 2, solid contact of 1 square inch area.

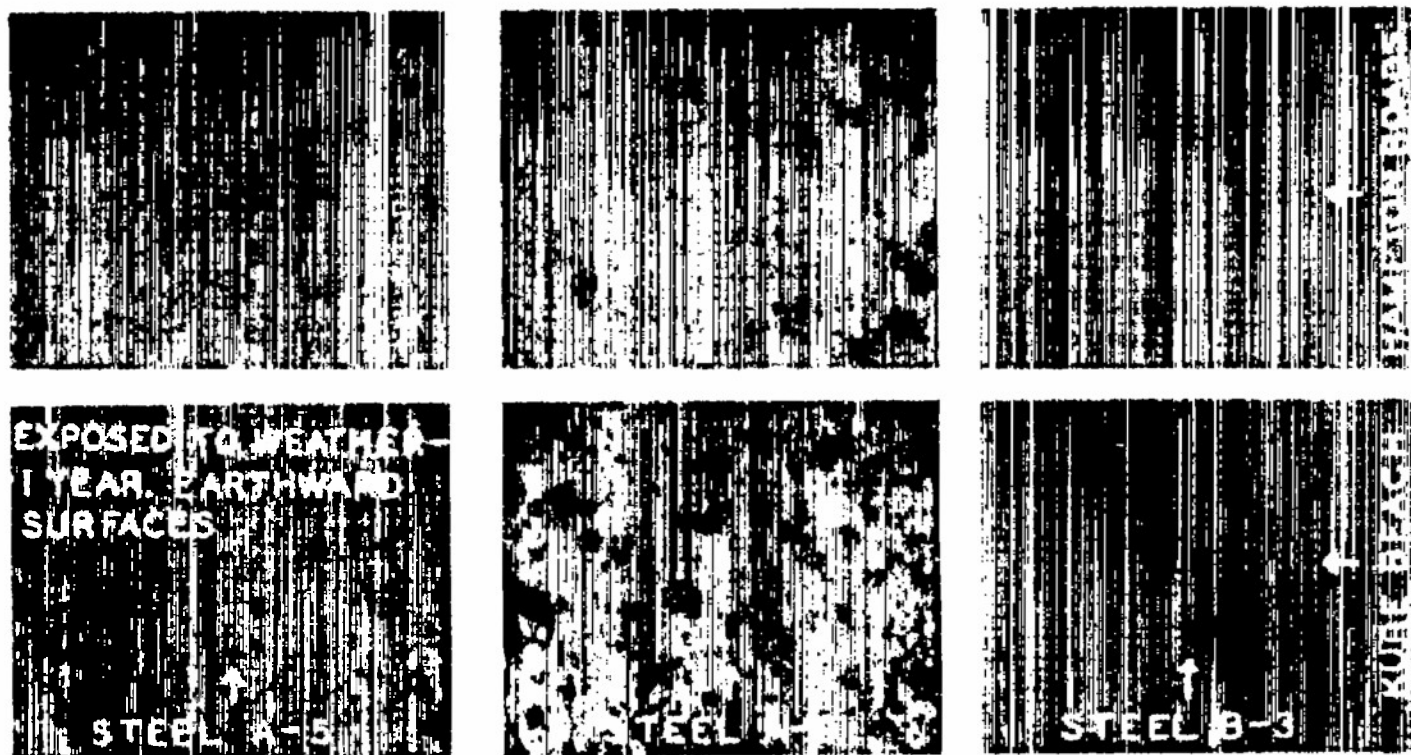
Figure 38.- Stainless steel panels, after a year's weather-exposure, were much more rusted at the Kure Beach site than at Hampton Roads. The molybdenum containing steel, however, was very much less rusted than the others. x 3/5.
